## Tip of the month/No. 9

### Using built-in rotary vane pumps

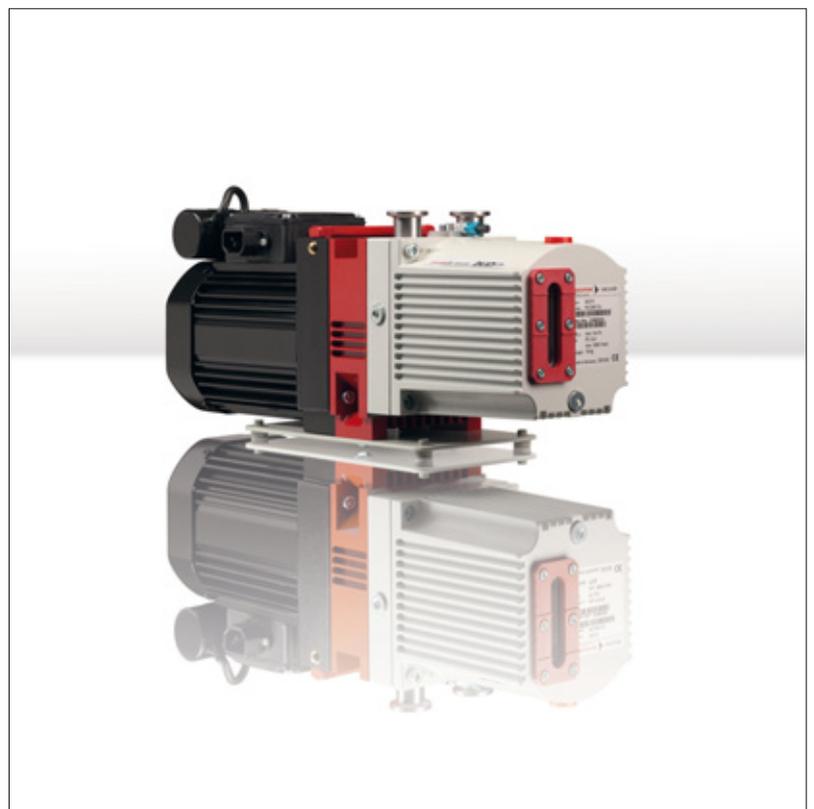
In this case, we would recommend using a new DuoLine series pump (DUO 1.6, DUO 3, DUO 6 or DUO 11). The air circulation through the entire pump is significantly improved in this series with an optimized motor flange design and improved device base. Together with additional cooling fins on the pump's oil reservoir, this results in a reduction in the surface temperature of 7 K in the case of the DUO 3 and of 16 K in fact with the DUO 1.6 compared to their previous versions.

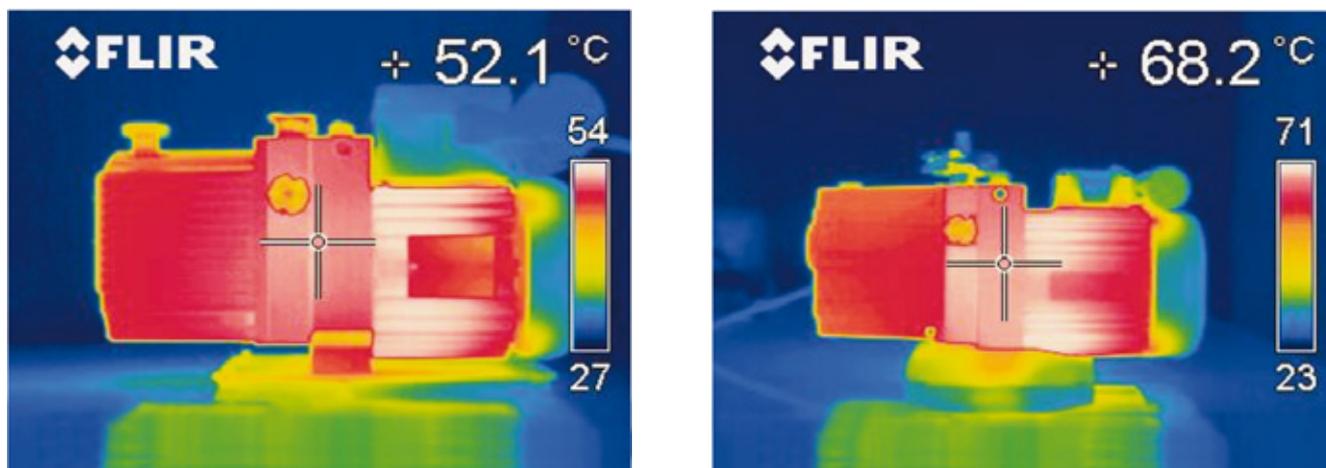
Fig.: Thermal image of the DUO 1.6 in comparison to the previous version DUO 1.3

The motor outputs for the DUO 1.6 are only 75 W and are 150 W for the DUO 3. With these outputs, in comparison to previous versions and other modules, significantly less electrical power loss is converted into heat and the entire instrument remains more thermally stable.

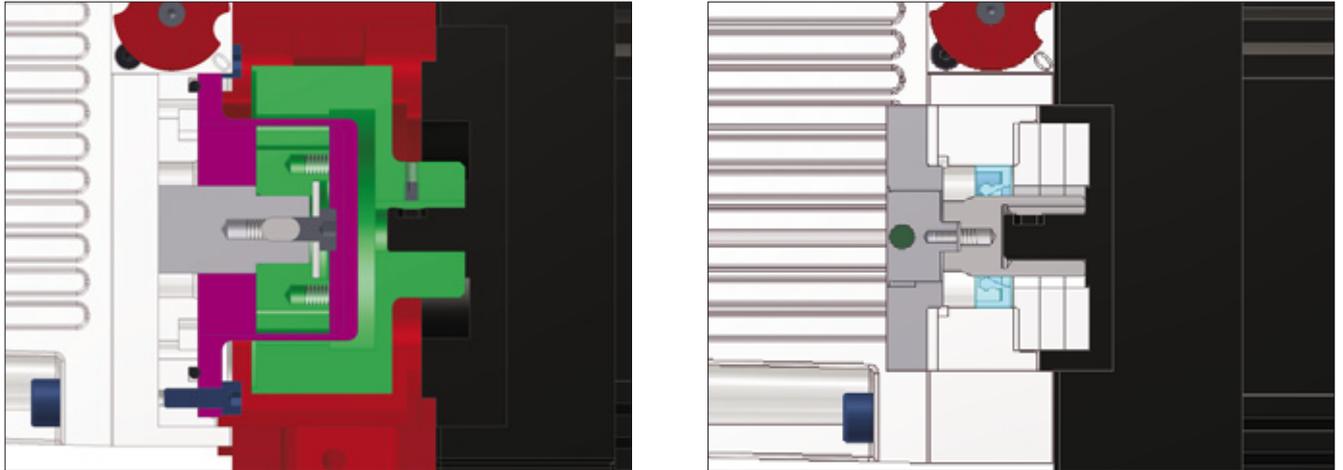
Fig.: Magnetic coupling compared to the use of a shaft seal

Oil accumulation may also be caused by leaks in the pump. Many current rotary vane pumps still use compressed cork seals on the oil reservoir. Instead, we recommend rotary vane pumps with guided O-ring seals. Another potential leak site is the shaft seal between the pump motor and suction chamber. A defective shaft seal is the most frequent cause of an oil leak from a rotary vane pump. For example, the shaft seal can be attacked by particles and crushed. Particles are not only introduced into the pump by processes but can also be generated inside the pump. There may be play between couplings joining individual pumping stages resulting in attrition. Particles generated in this way can then settle on the shaft or shaft sleeve and crush or wear down the seal. Operating the pump at low temperatures also results in reduced hardening of the shaft seal. The low operating temperature of the new DuoLine pumps and the fact that they no longer use coupling stages results in a longer service life for the shaft seal and longer maintenance intervals.

Shaft seals can be avoided at the design stage by using magnetic couplings. Rotary vane pumps such as those in the DUO M series do not have rotating shafts leading out of the pump block, and so provide the best possible long-term leak-tightness at this point.
